# Manhole Inspection Summary

Manhole # S31G\_\_033MH

Insp Date: **8/1/08 1:33 PM**

**Location** Address: **16 s eutaw st**

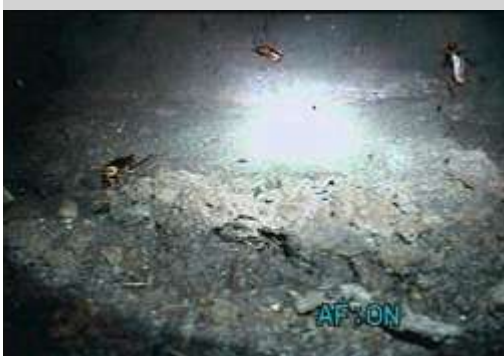
Defect 3

Condition: ☐ Sound ☐ Cracked ☐ Root Intrusion ☐ Deteriorated ☐ Leaks ☒ **Debris**

channel debris

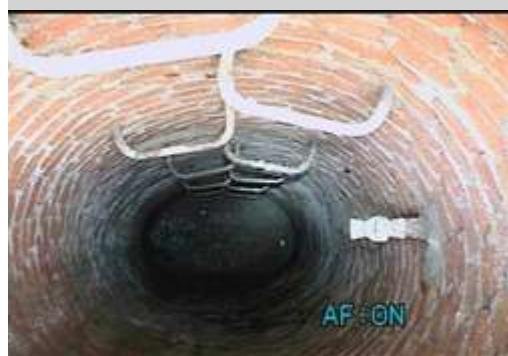
Defect 2

Count: **11** Missing: **0** ☒ **Corroded**

corroded steps

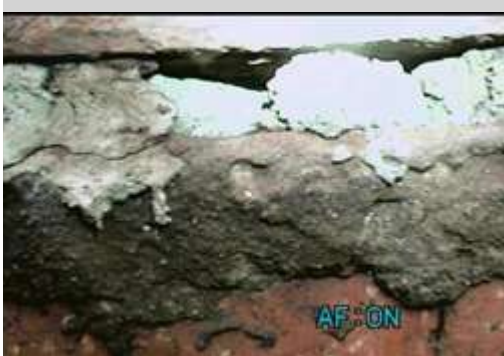
Defect 1

Condition: ☐ Sound ☐ Cracked ☐ Root Intrusion ☒ **Loose Brick** ☒ **Deteriorated**

chimney loose bricks and deteriorated,  
frame adj
